EXHIBIT 7

July 26, 2019

As you requested, this is a letter report on the vegetation management field inspections ("VM inspections") the Monitor team is conducting pursuant to the Court's April 3, 2019 Order ("April 3 Order"). This submission includes: (1) background information on the VM inspections; (2) an explanation of the VM inspections process; (3) the Monitor team's preliminary observations; (4) PG&E's feedback based on the Monitor team's preliminary findings; (5) the Monitor team's preliminary suggestions to PG&E, as shared with the Company on July 17, 2019; and (6) concluding thoughts.

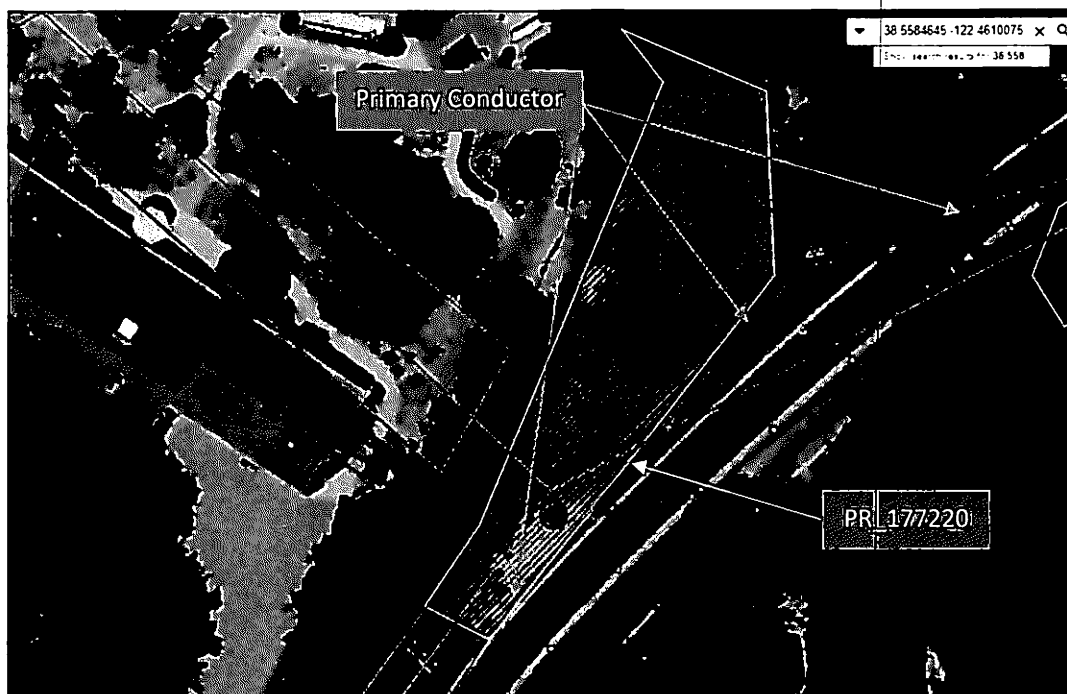
A potential overhang tree was found during a Monitor Inspection on July 1, 2019 of Project *PR_177220* on Circuit *Silverado 2104*. In general terms, this circuit is located on the outskirts of the city of St. Helena, CA, running approximately 15 miles to the north of the city. This circuit is located in/near a Tier 3 fire threat area pursuant to the ArcCollector database. The approximate position of the tree is denoted as the red circle in the second graphic below.

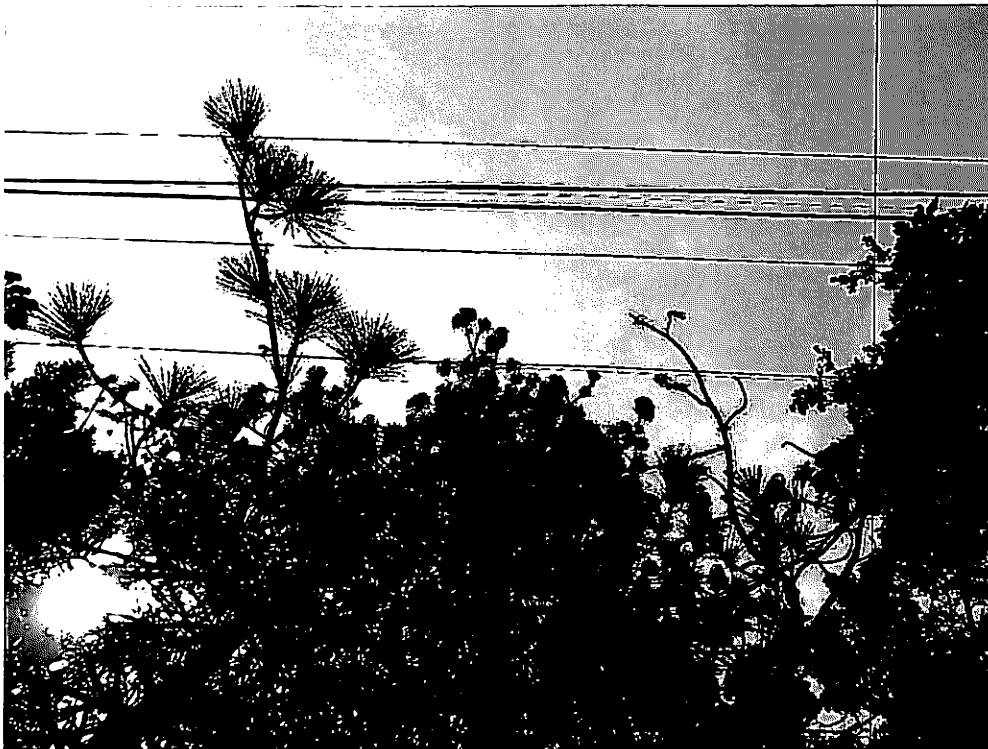
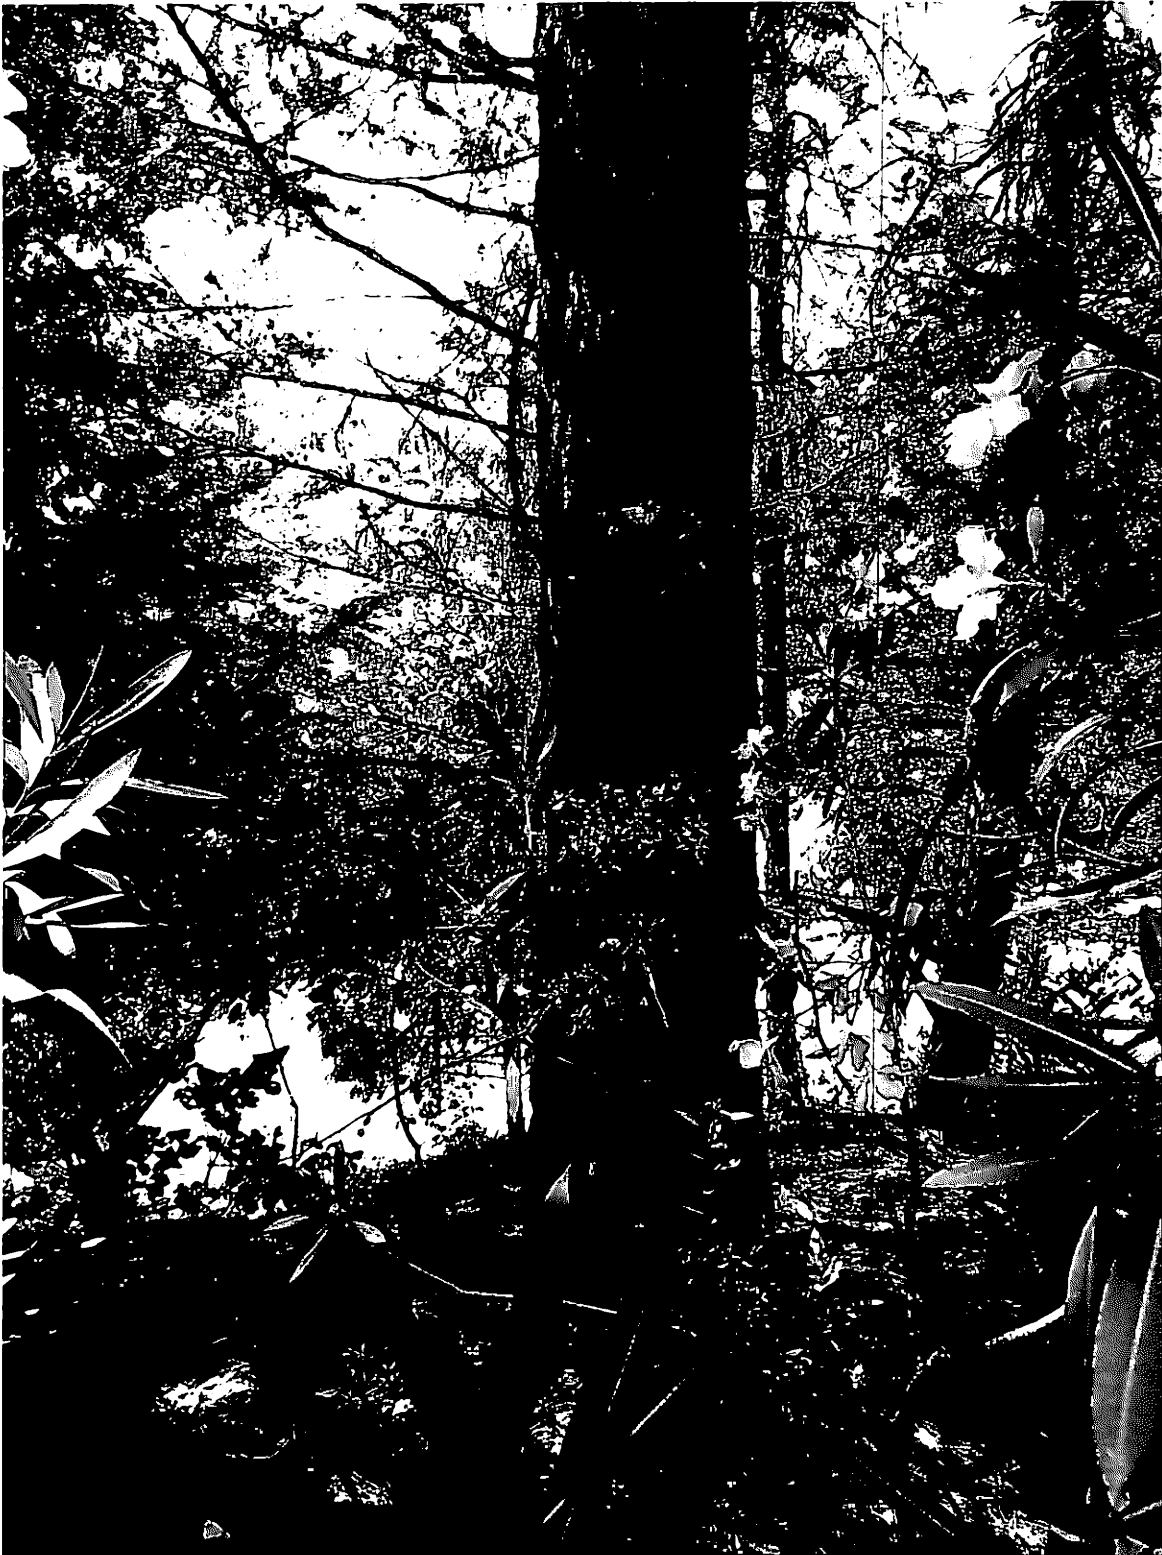
PG&E ArcCollector Project Status	In-Progress
Monitor Team Observed Tree Work in Immediate Vicinity of Subject Tree	No
Monitor Team Observed Recent Tree Work on Subject Tree	No
Tree Paint or Other Markings Observed	No paint observed
Species	Ponderosa Pine
GPS Coordinates	38.5584645, -122.4610075
Approx. Distance from Primary Conductor	Trunk of tree 20 feet northwest
Approx. Height	90 feet
Veg Type	Potential Overhang Tree
Monitor Arborist Comment	Vegetation observed currently overhanging the 4 foot vertical plane, and tree not visibly marked for pruning.

Photographs below show subject tree and proximity to the primary conductor.

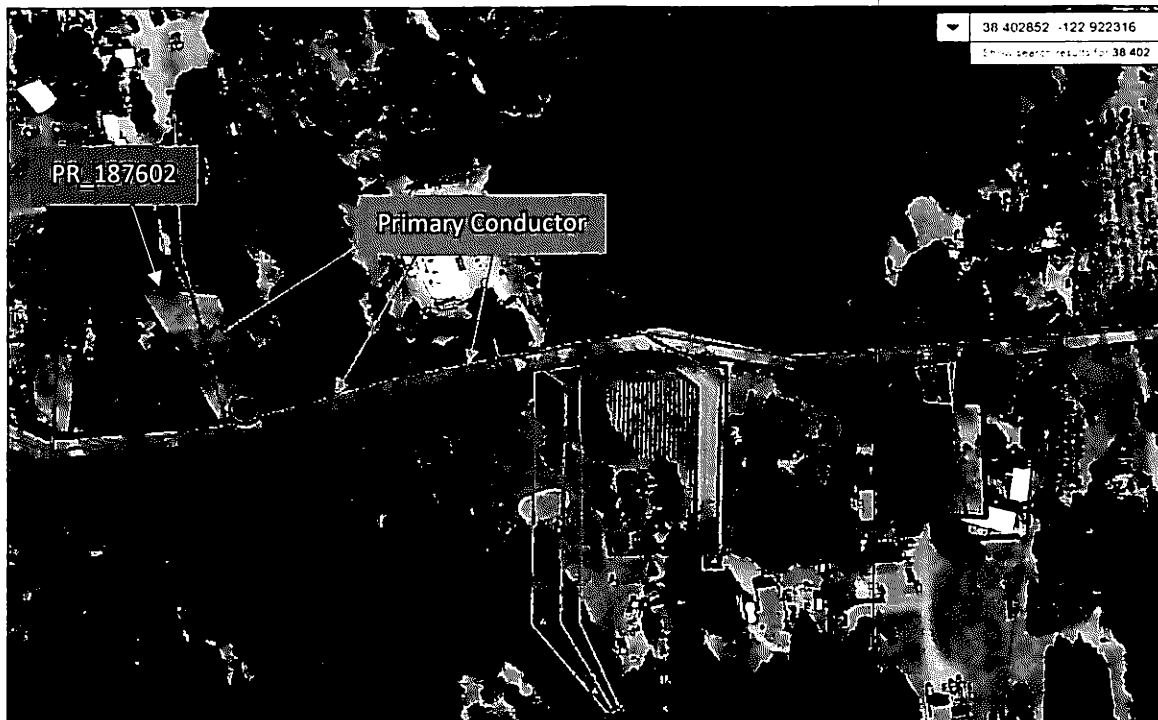
A potential overhang tree was found during a Monitor Inspection on July 2, 2019 of Project *PR_187602* on Circuit *Molino 1102*. In general terms, this circuit is located on the outskirts of the city of Sebastopol, CA, running approximately 10 miles to the west of the city. This circuit is located in/near a Tier 3 fire threat area pursuant to the ArcCollector database. The approximate position of the tree is denoted as the red circle in the second graphic below.

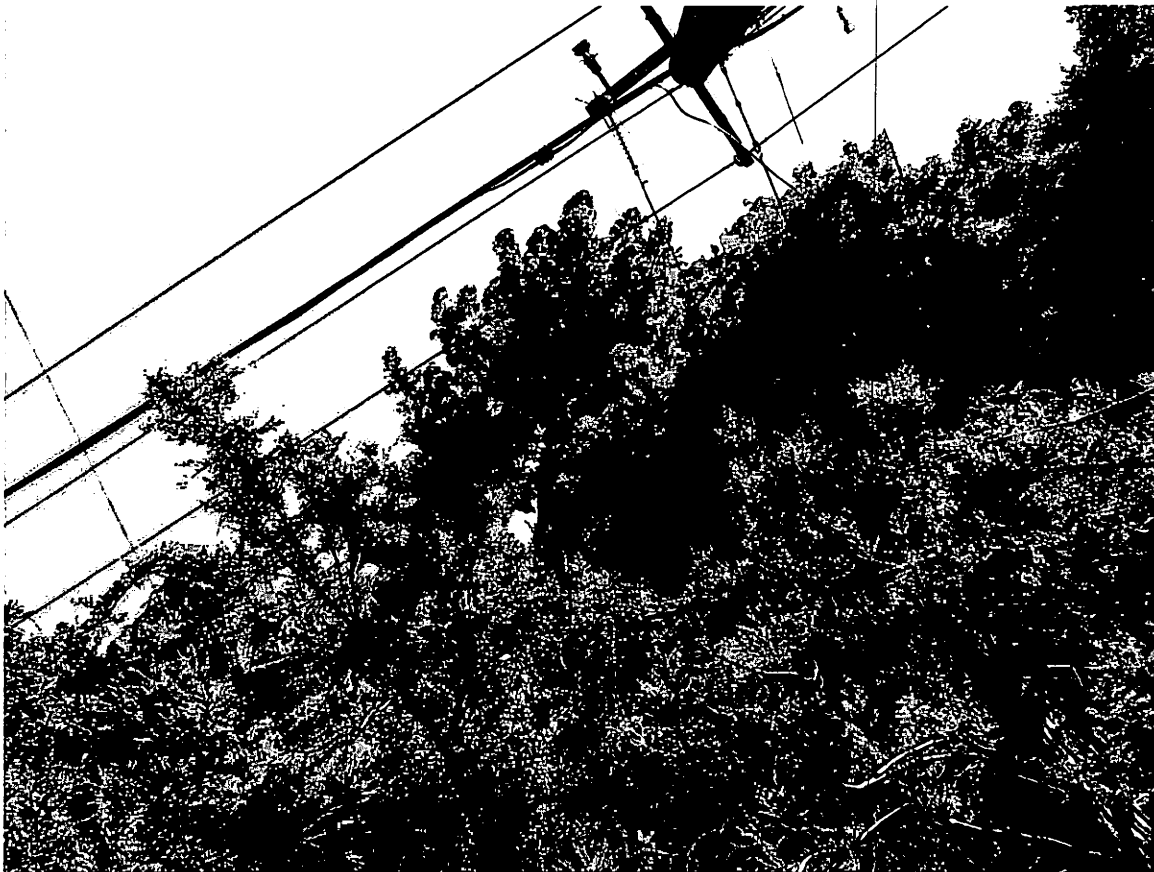
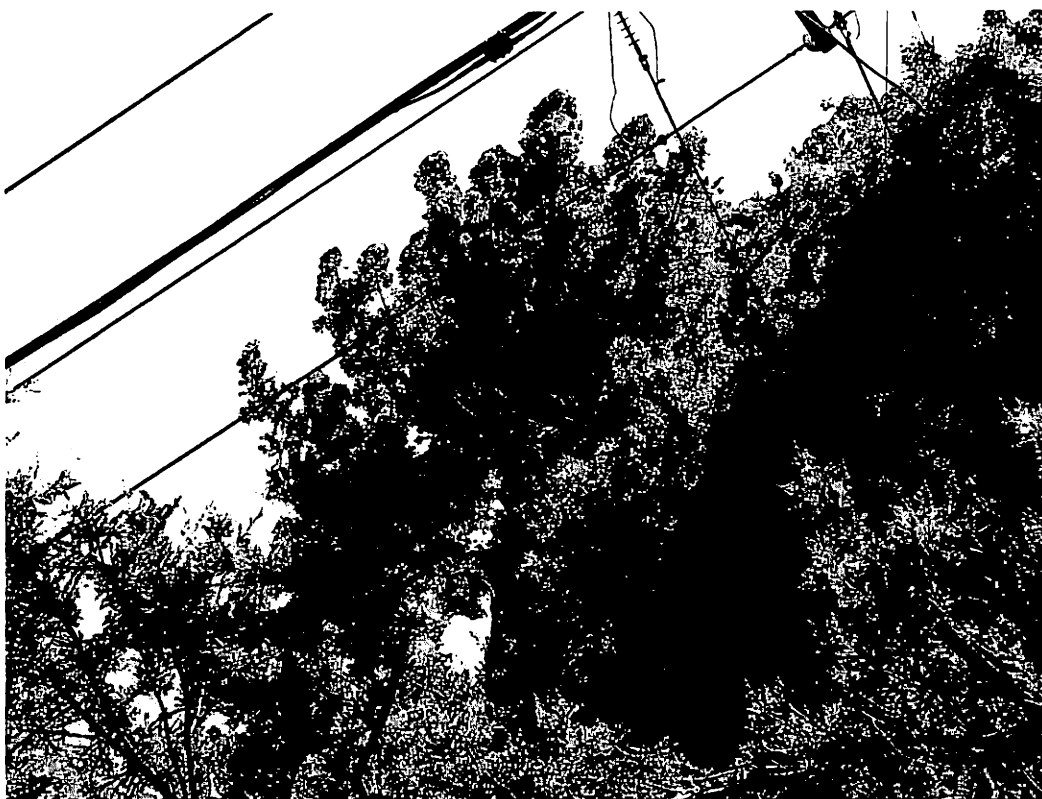
PG&E ArcCollector Project Status	No Work Required Under EVM
Monitor Team Observed Tree Work in Immediate Vicinity of Subject Tree	No
Species	Coastal Redwood
GPS Coordinates	38.402852, -122.922316
Approx. Distance from Primary Conductor	Trunk of tree 5 feet north
Approx. Height	115 feet
Veg Type	Potential Overhang Tree
Monitor Arborist Comment	Vegetation observed currently overhanging the 4 foot vertical plane

Photographs below show subject tree and proximity to the primary conductor.

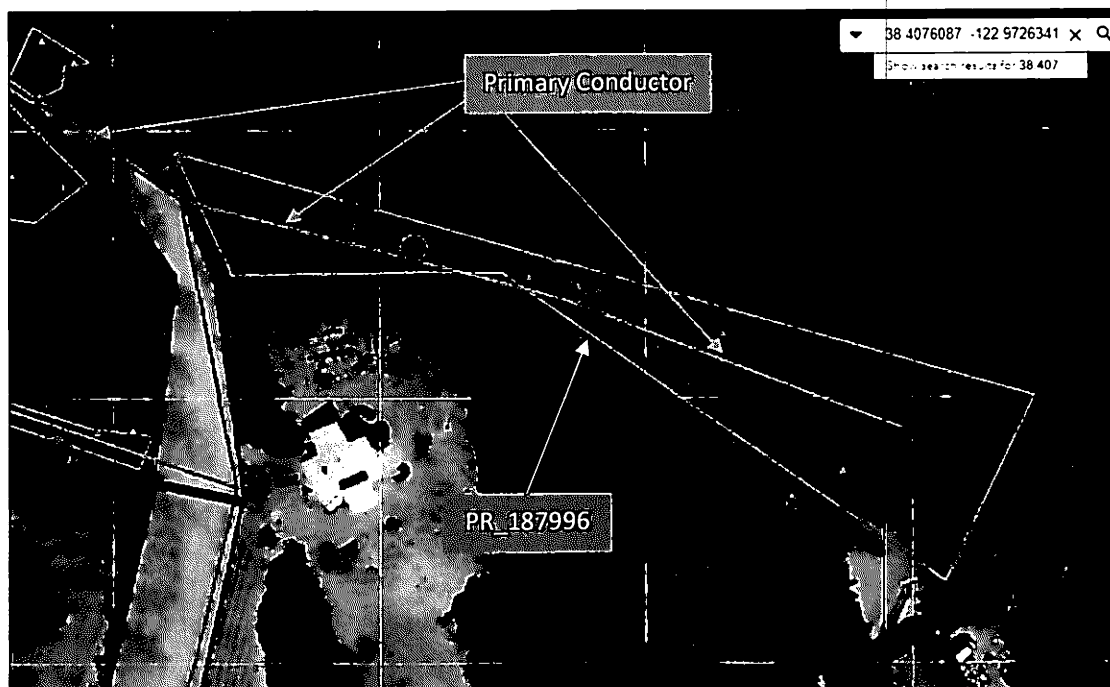
A potential overhang tree was found during a Monitor Inspection on July 1, 2019 of Project *PR_187996* on Circuit *Molino 1102*. In general terms, this circuit is located on the outskirts of the city of Sebastopol, CA, running approximately 10 miles to the west of the city. This circuit is located in/near a Tier 3 fire threat area pursuant to the ArcCollector database. The approximate position of the tree is denoted as the red circle in the second graphic below.

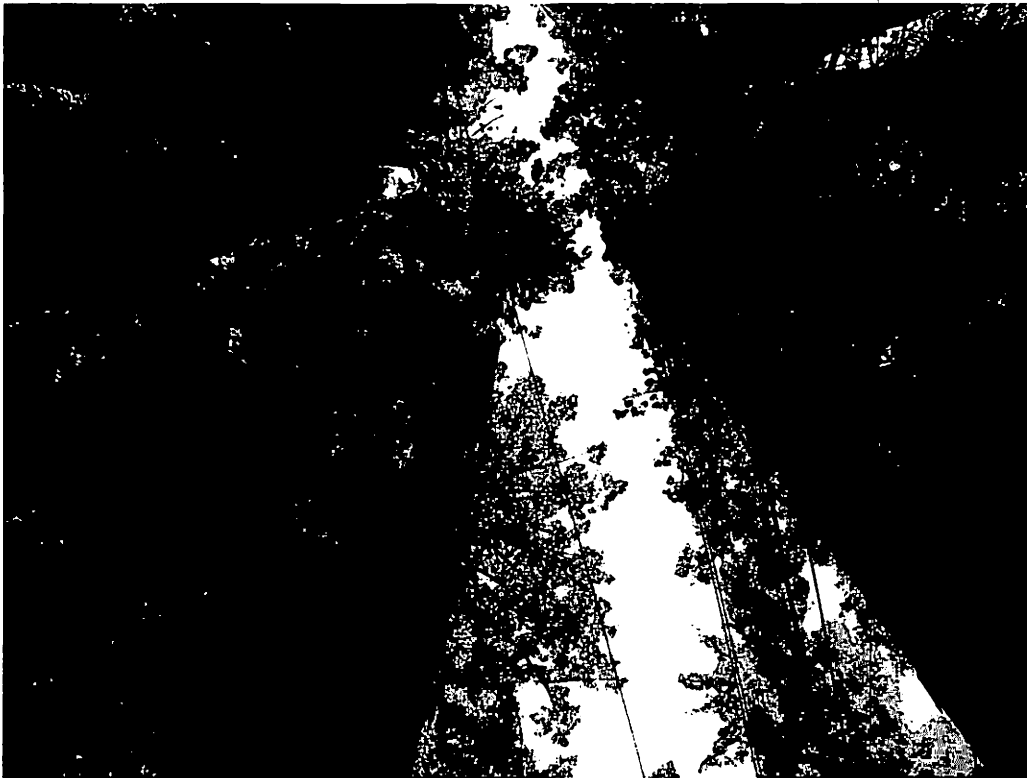
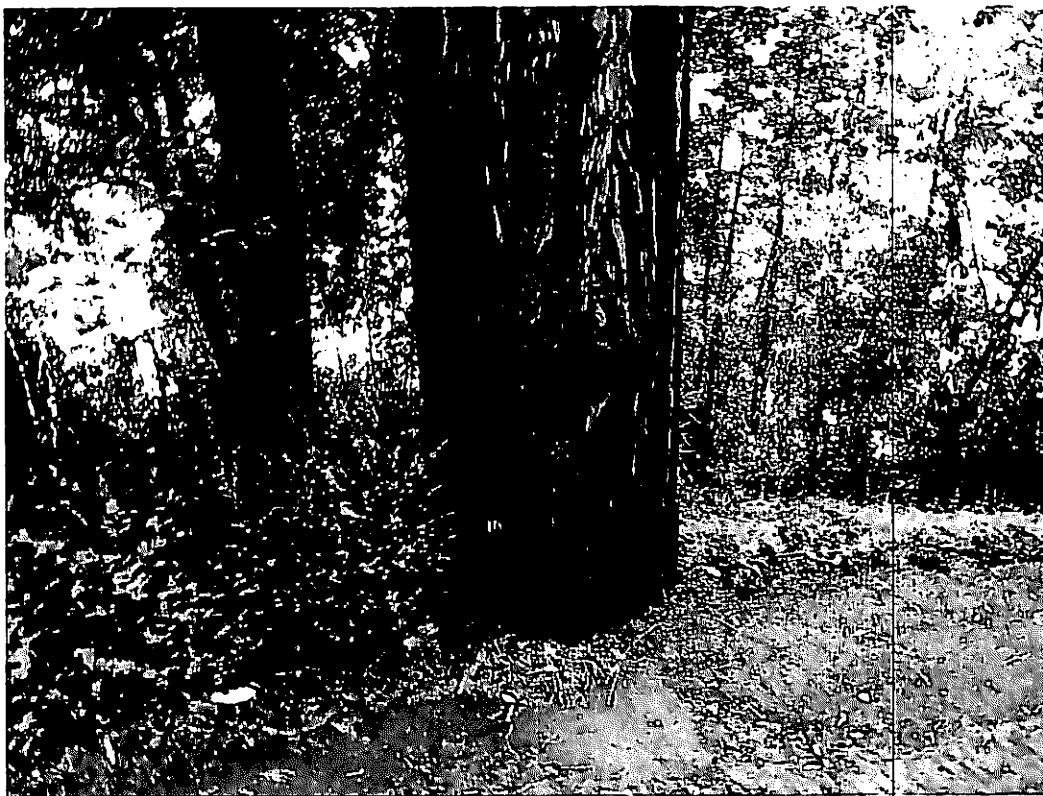
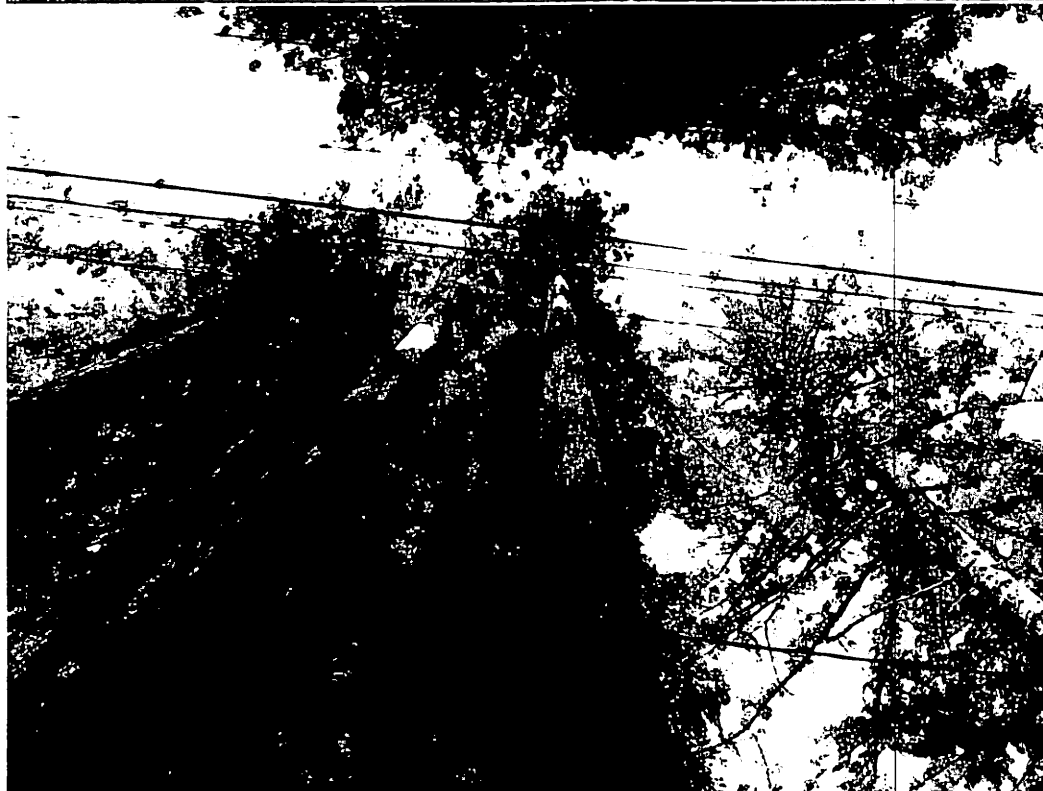
PG&E ArcCollector Project Status	Work Identified
Monitor Team Observed Tree Work in Immediate Vicinity of Subject Tree	No
Monitor Team Observed Recent Tree Work on Subject Tree	No
Tree Paint or Other Markings Observed	No paint observed
Species	Coastal Redwood
GPS Coordinates	38.4076087, -122.9726341
Approx. Distance from Primary Conductor	Trunk of tree 3 feet north
Approx. Height	120 feet
Veg Type	Potential Overhang Tree
Monitor Arborist Comment	Vegetation observed currently overhanging the 4 foot vertical plane, and tree not visibly marked for pruning.

Photographs below show subject tree and proximity to the primary conductor.

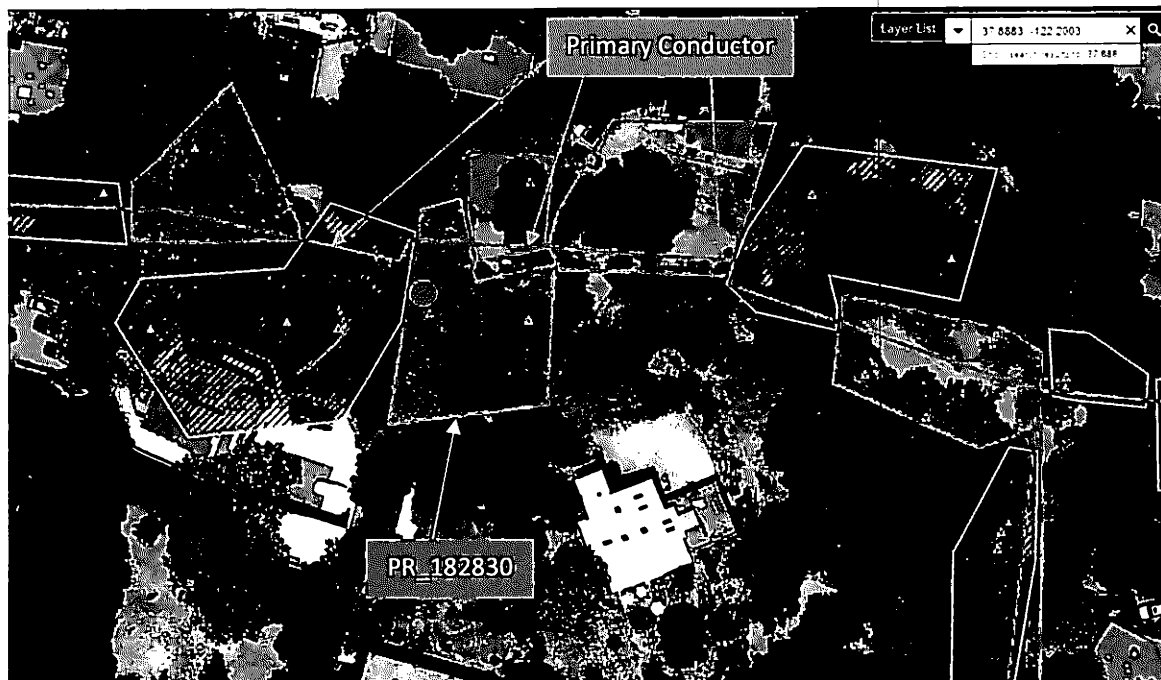
A tree with a potential radial clearance issue was found during a Monitor Inspection on June 3, 2019 of Project *PR_182830* on Circuit *Orinda 0401*. In general terms, this project is located approximately 5 miles east of Berkeley, CA in the city of Orinda and is located in/near a Tier 3 fire threat area pursuant to the ArcCollector database. The approximate position of the tree is denoted as the red circle in the second graphic below.

PG&E ArcCollector Project Status	Wood Mgmt Complete
Monitor Team Observed Tree Work in Immediate Vicinity of Subject Tree	Yes
Species	Valley Oak
GPS Coordinates	37.8883, -122.2003
Approx. Distance from Primary Conductor	Trunk of tree 3 feet south
Approx. Height	65 feet
Veg Type	Potential Radial Clearance Tree
Monitor Arborist Comment	Vegetation with evidence of pruning observed within 12 feet of primary conductor

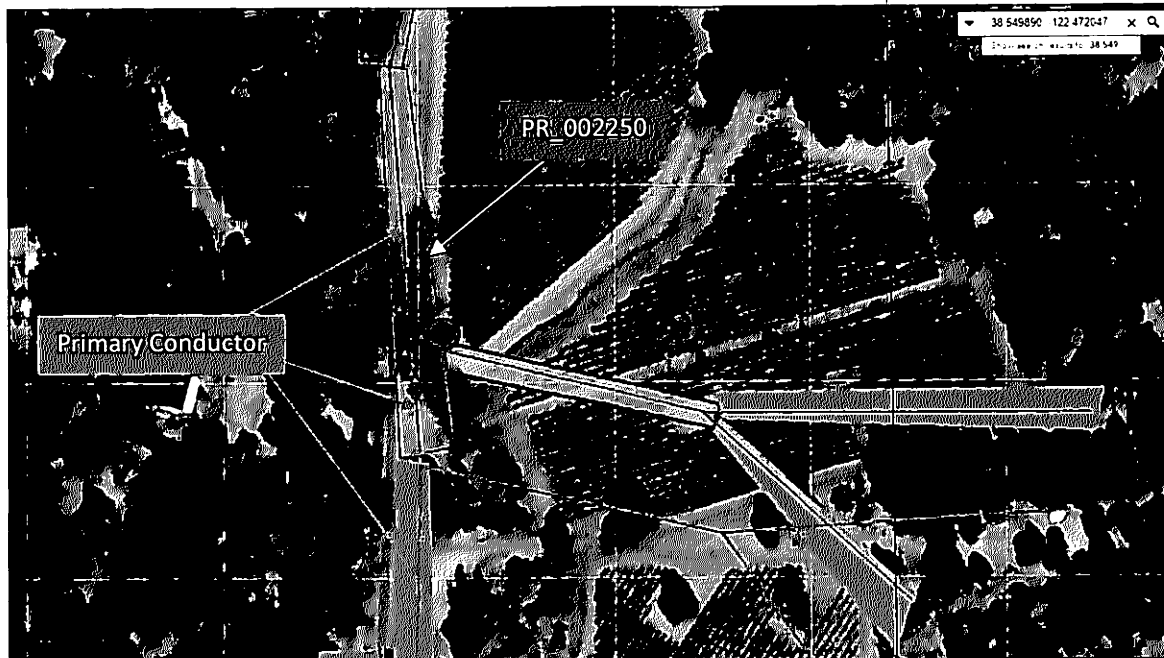
A potential radial clearance tree was found during a Monitor Inspection on June 24, 2019 of Project *PR_002250* on Circuit *Silverado 2104*. In general terms, this circuit is located on the outskirts of the city of St. Helena, CA, running approximately 15 miles to the north of the city. This circuit is located in/near a Tier 3 fire threat area pursuant to the ArcCollector database. The approximate position of the tree is denoted as the red circle in the second graphic below.

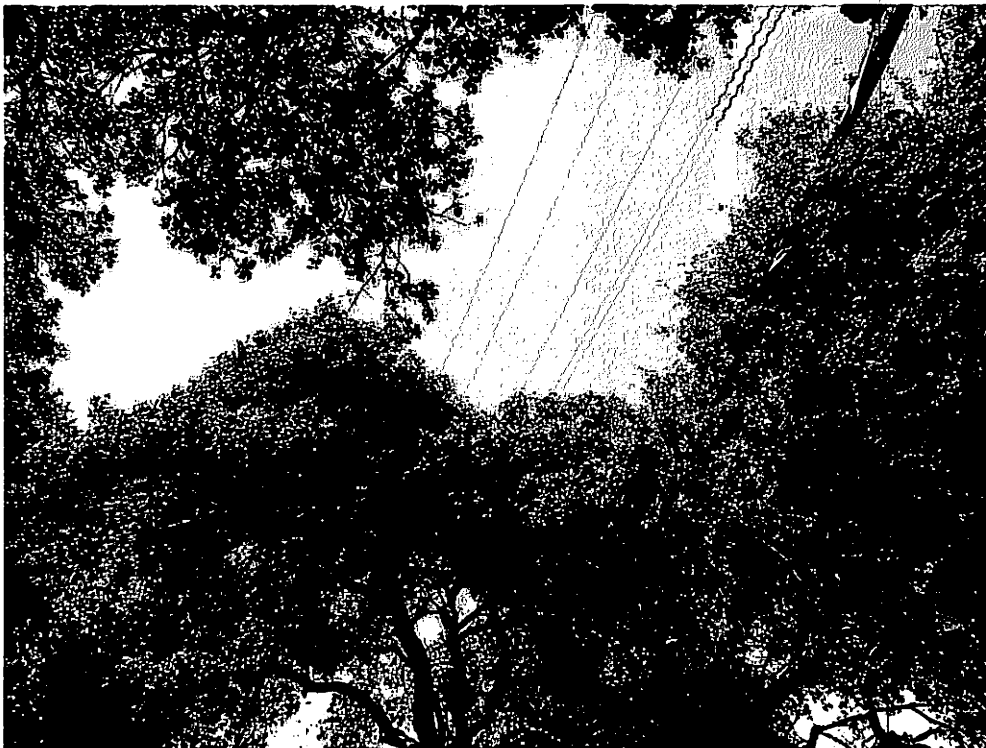
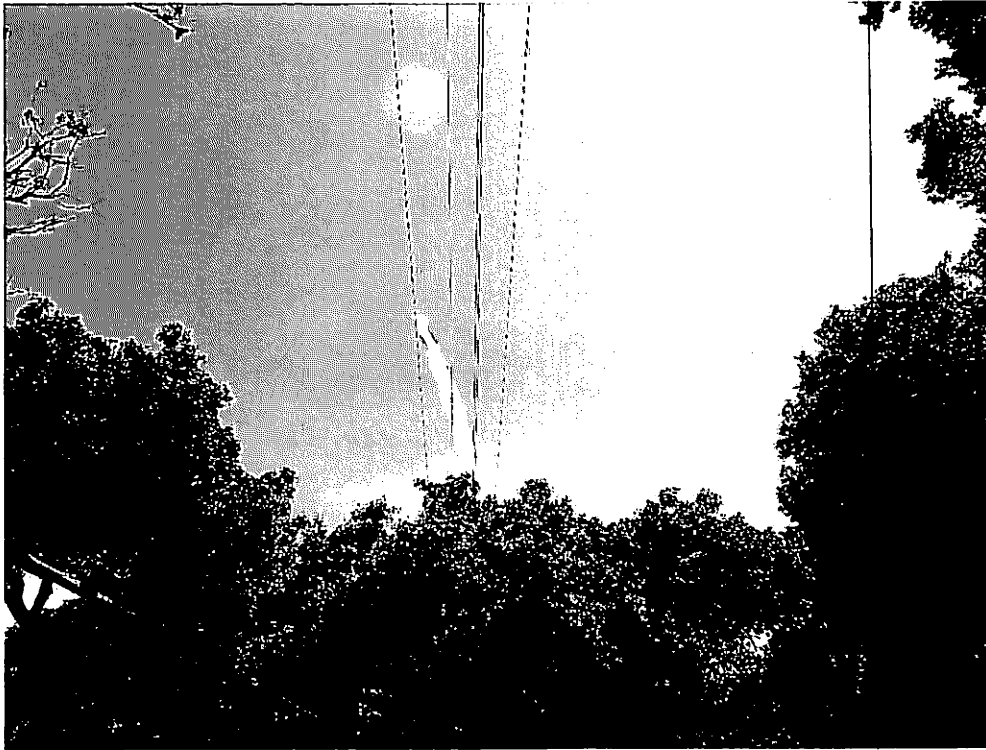
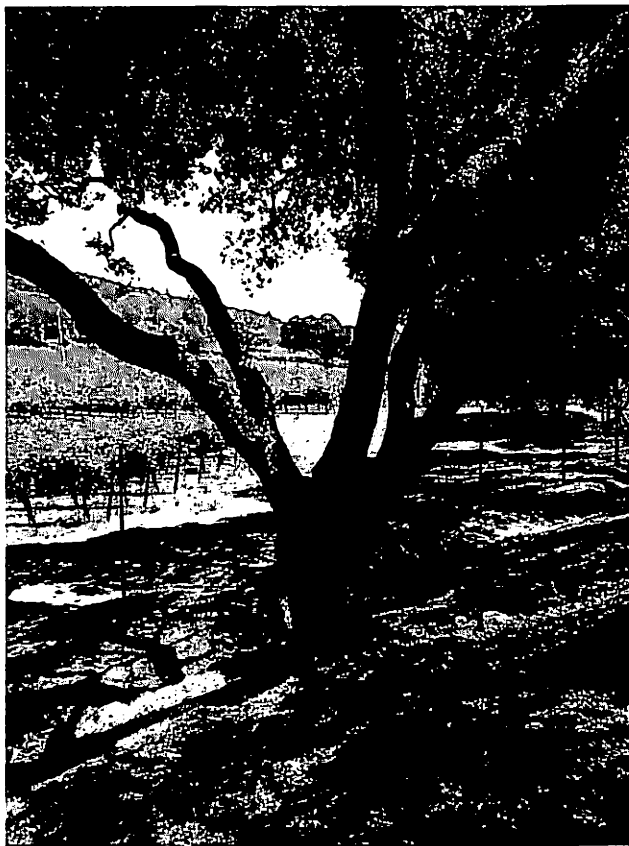
PG&E ArcCollector Project Status	Tree Work Complete
Monitor Team Observed Tree Work in Immediate Vicinity of Subject Tree	Yes
Monitor Team Observed Recent Tree Work on Subject Tree	Yes
Tree Paint or Other Markings Observed	Yellow dot
Species	Coastal Live Oak
GPS Coordinates	38.549890, -122.472047
Approx. Distance from Primary Conductor	Trunk of tree underneath primary conductor
Approx. Height	35 feet
Veg Type	Potential Radial Clearance Tree
Monitor Arborist Comment	Vegetation with evidence of pruning observed within 12 feet of primary conductor

Photographs below show subject tree and proximity to the primary conductor.

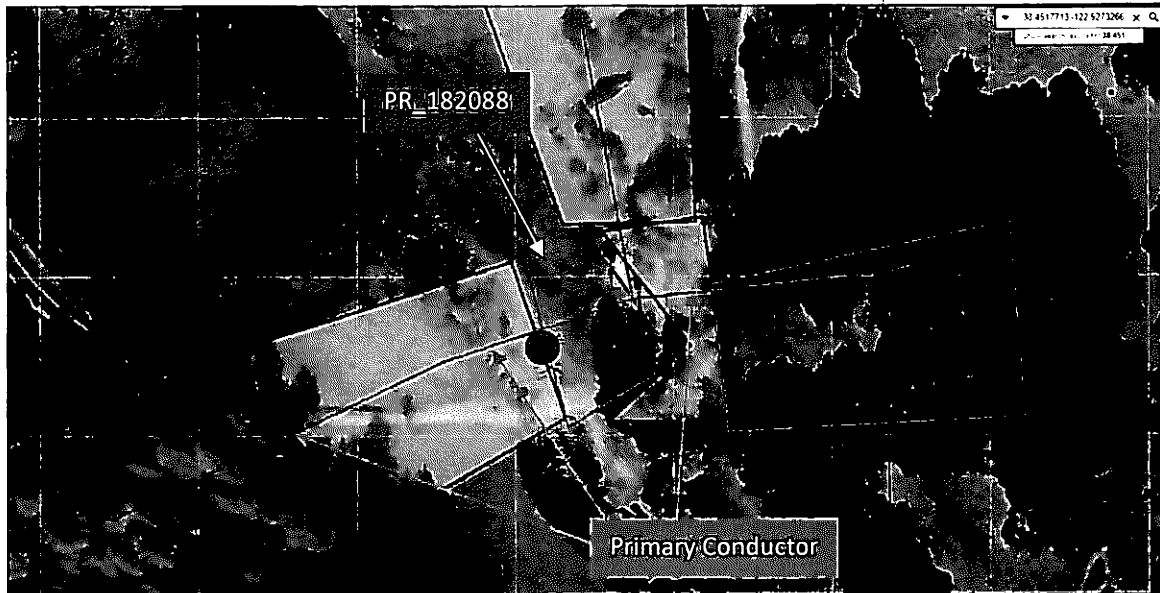
A potential radial clearance tree was found during a Monitor Inspection on June 28, 2019 of Project *PR_182088* on Circuit *Molino 1102*. In general terms, this circuit is located on the outskirts of the city of Sebastopol, CA, running approximately 10 miles to the west of the city. This circuit is located in/near a Tier 3 fire threat area pursuant to the ArcCollector database. The approximate position of the tree is denoted as the red circle in the second graphic below.

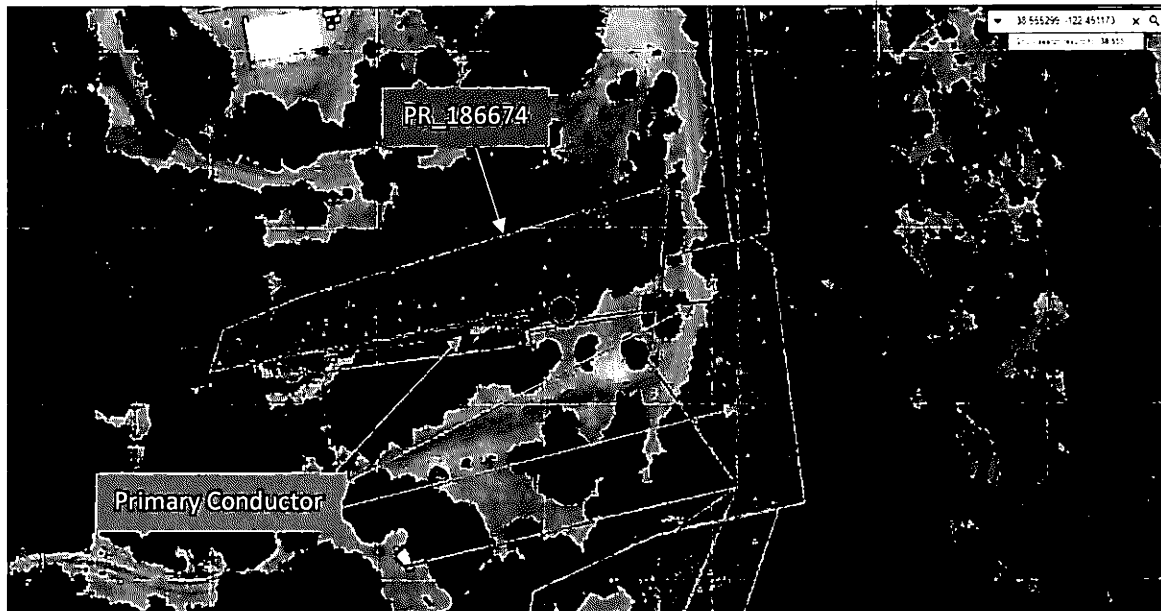
A potential radial clearance tree was found during a Monitor Inspection on June 25, 2019 of Project *PR_186674* on Circuit *Silverado 2104*. In general terms, this circuit is located on the outskirts of the city of St. Helena, CA, running approximately 15 miles to the north of the city. This circuit is located in/near a Tier 3 fire threat area pursuant to the ArcCollector database. The approximate position of the tree is denoted as the red circle in the second graphic below.

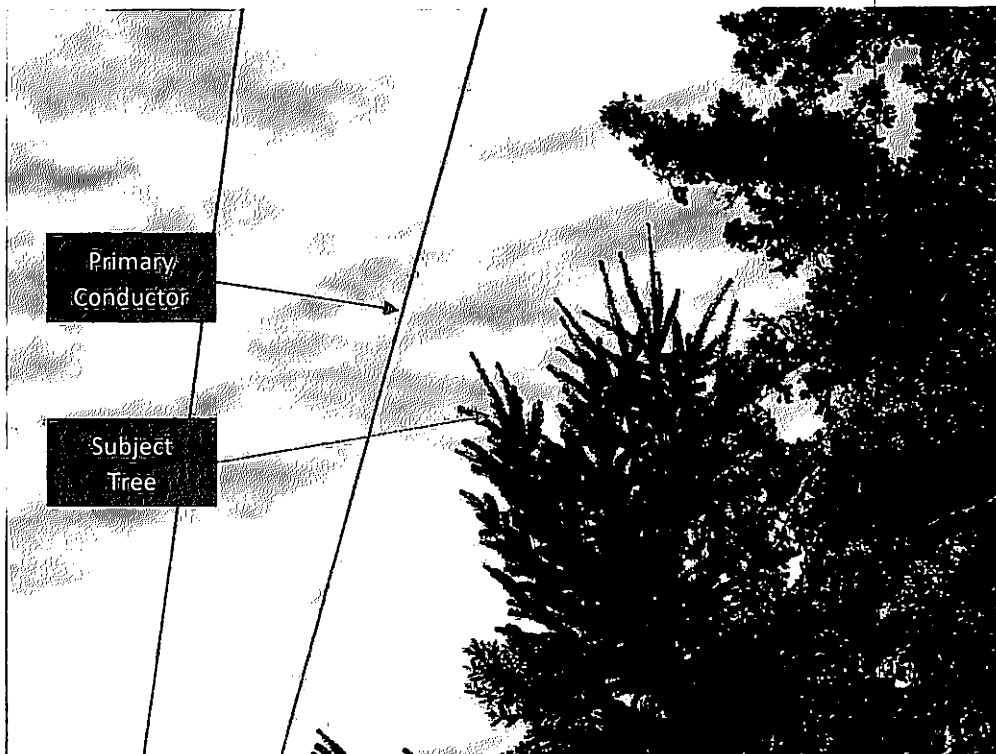
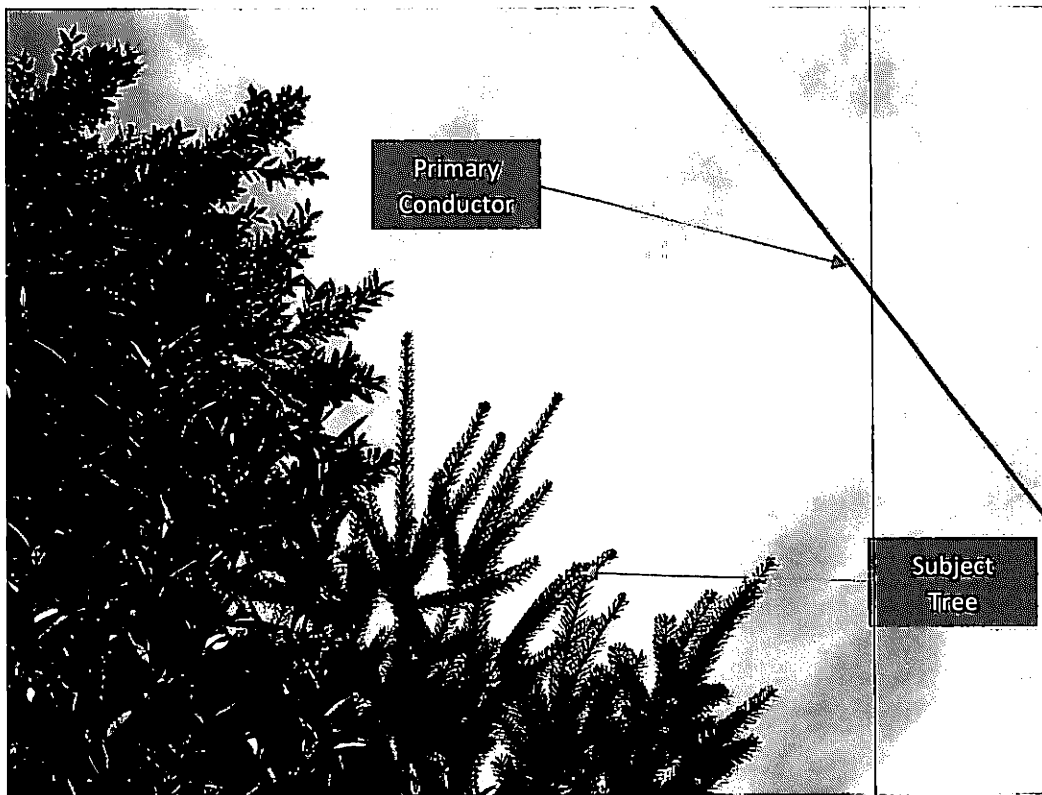
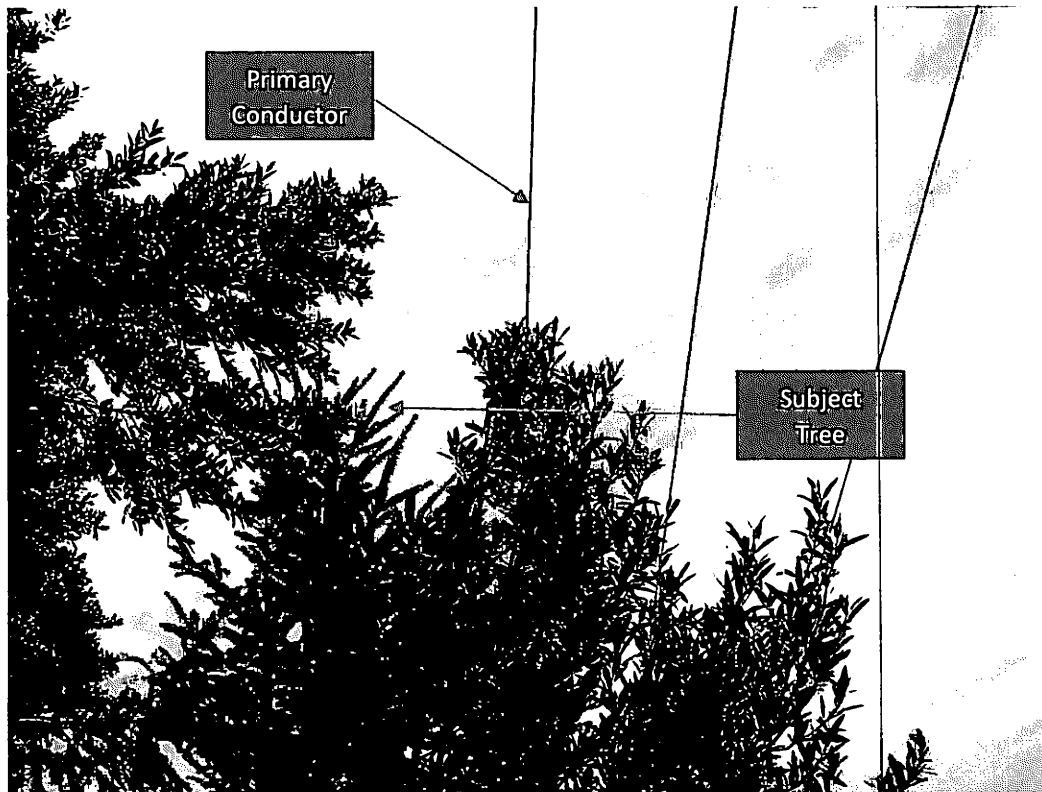
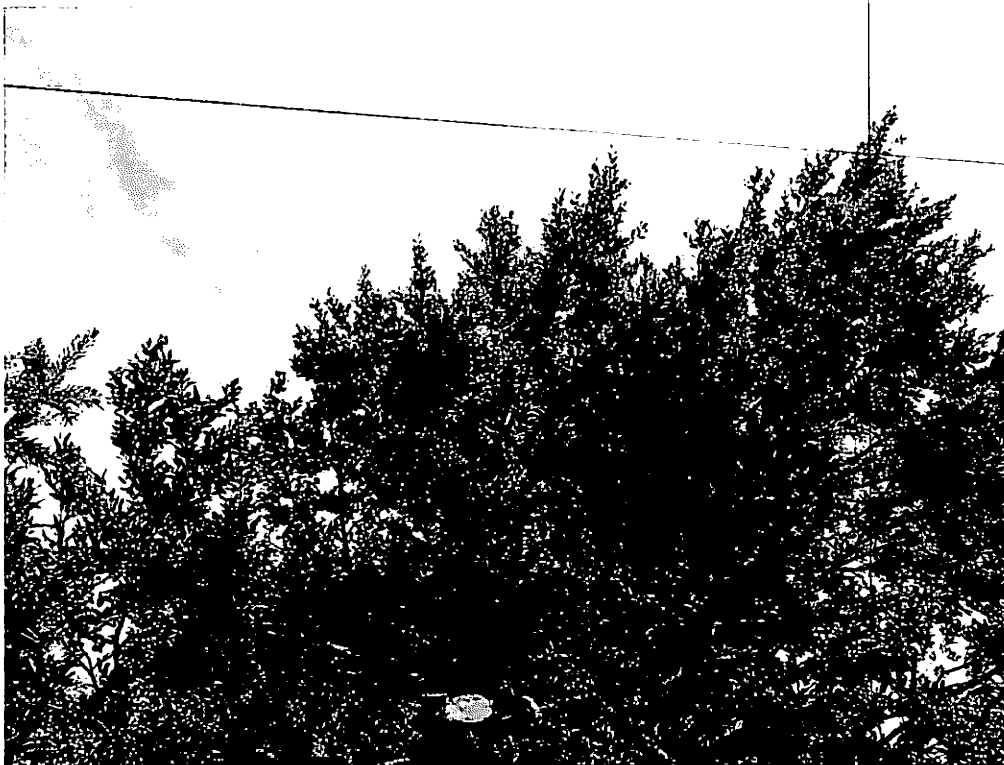
PG&E ArcCollector Project Status	Wood Mgmt Complete
Monitor Team Observed Tree Work in Immediate Vicinity of Subject Tree	Yes
Monitor Team Observed Recent Tree Work on Subject Tree	No
Tree Paint or Other Markings Observed	No paint observed
Species	Douglas Fir
GPS Coordinates	38.555299, -122.451173
Approx. Distance from Primary Conductor	Trunk of tree 2 feet north
Approx. Height	30 feet
Veg Type	Potential Radial Clearance Tree
Monitor Arborist Comment	Vegetation observed within 4 feet of primary conductor

Photographs below show subject tree and proximity to the primary conductor.

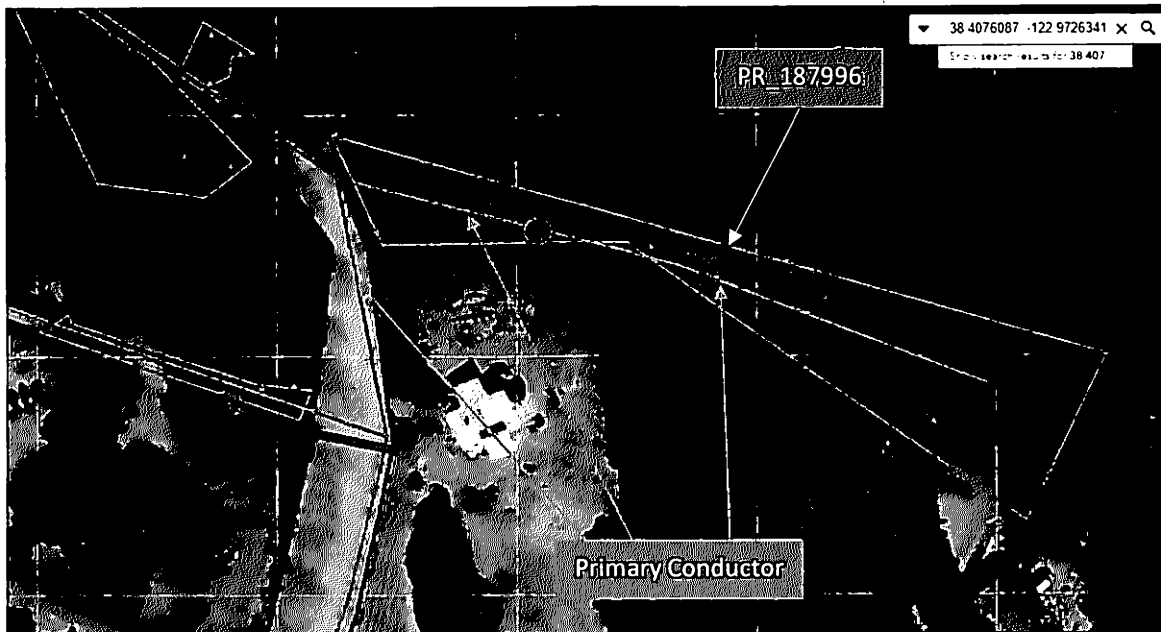
A potential radial clearance tree was found during a Monitor Inspection on July 1, 2019 of Project *PR_187996* on Circuit *Molino 1102*. In general terms, this circuit is located on the outskirts of the city of Sebastopol, CA, running approximately 10 miles to the west of the city. This circuit is located in/near a Tier 3 fire threat area pursuant to the ArcCollector database. The approximate position of the tree is denoted as the red circle in the second graphic below.

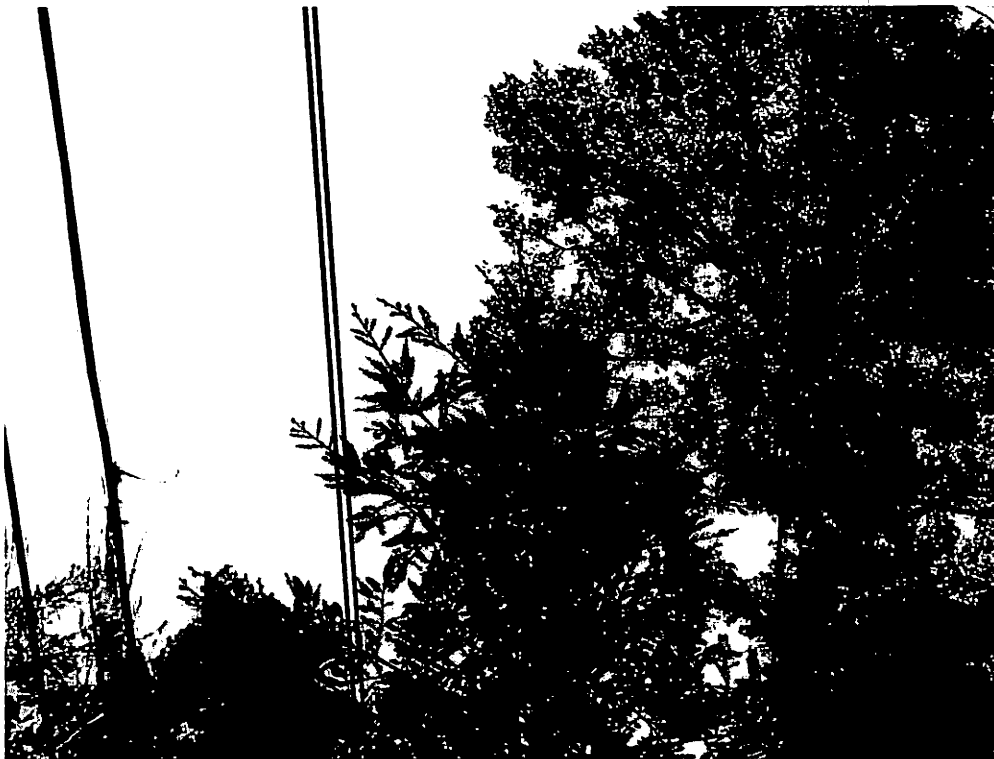
PG&E ArcCollector Project Status	Work Identified	
Monitor Team Observed Tree Work in Immediate Vicinity of Subject Tree	No	
Monitor Team Observed Recent Tree Work on Subject Tree	No	
Tree Paint or Other Markings Observed	No paint observed	
Species	Coastal Redwood	
GPS Coordinates	38.4076087, -122.9726341	
Approx. Distance from Primary Conductor	Trunk of tree 2 feet south of the primary conductor	
Approx. Height	25 feet	
Veg Type	Potential Radial Clearance Tree	
Monitor Arborist Comment	Vegetation observed within 4 feet of primary conductor, and tree not visibly marked for pruning.

Photographs below show subject tree and proximity to the primary conductor.

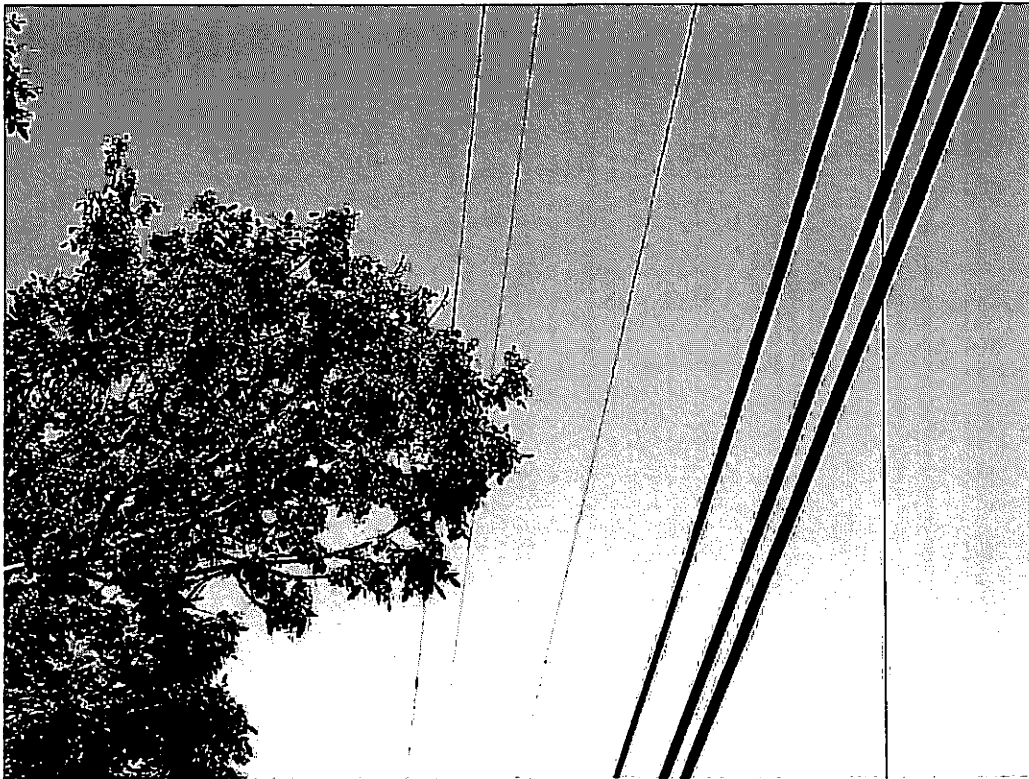
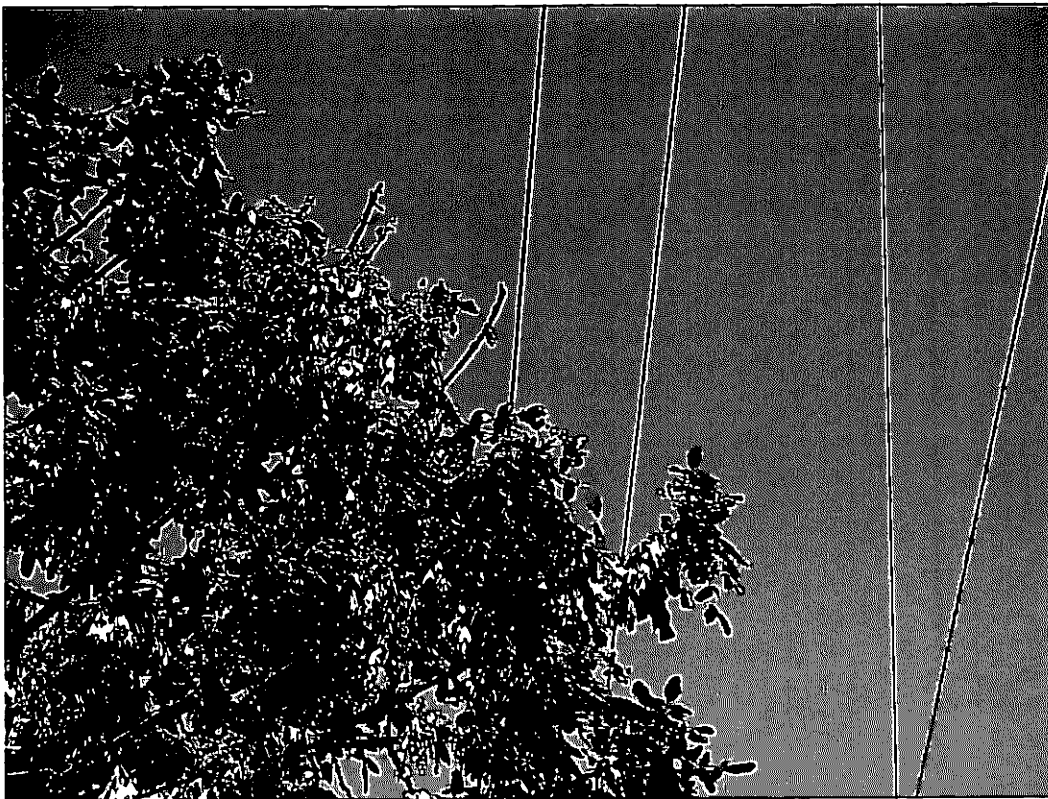
PG&E ArcCollector Project Status	Work Identified
Monitor Team Observed Tree Work in Immediate Vicinity of Subject Tree	No
Monitor Team Observed Recent Tree Work on Subject Tree	No
Tree Paint or Other Markings Observed	Flagging observed
Species	Ash
GPS Coordinates	38.380354, -122.931494
Approx. Distance from Primary Conductor	Trunk of tree 20 feet southwest
Approx. Height	32 feet
Veg Type	Potential Radial Clearance Tree
Monitor Arborist Comment	Vegetation observed within 4 feet of primary conductor, and tree has potentially been in contact with the primary conductor, as what appear to be singed branch tips can be observed from the ground.

Photographs below show subject tree and proximity to the primary conductor.
